LEARNING FROM IMAGES

Guidewire Position as a Guide to the Appropriate Positioning of Dialysis Catheter

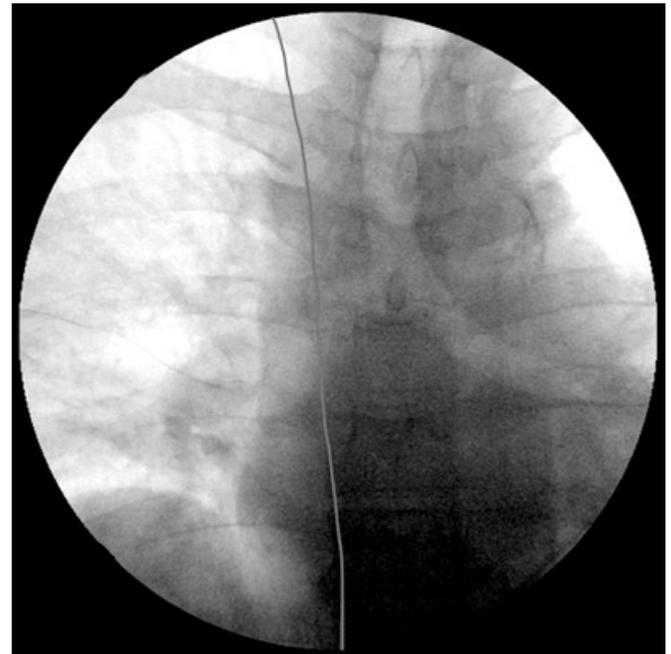
Fig. (1). Right internal jugular guidewire (arrows) in superior vena cava (Guidewire has been enhanced for easier visibility).

Firstly, it is important to recognize the normal position of a guidewire (or catheter) in the superior vena cava (Fig. 1). The course followed by the correctly positioned device within the superior vena cava is vertical and lateral to the vertebral column, in the lateral portion of the mediastinum [1]. When viewed in a lateral projection, the course of the device is in the mid-mediastinum, in a relatively straight line

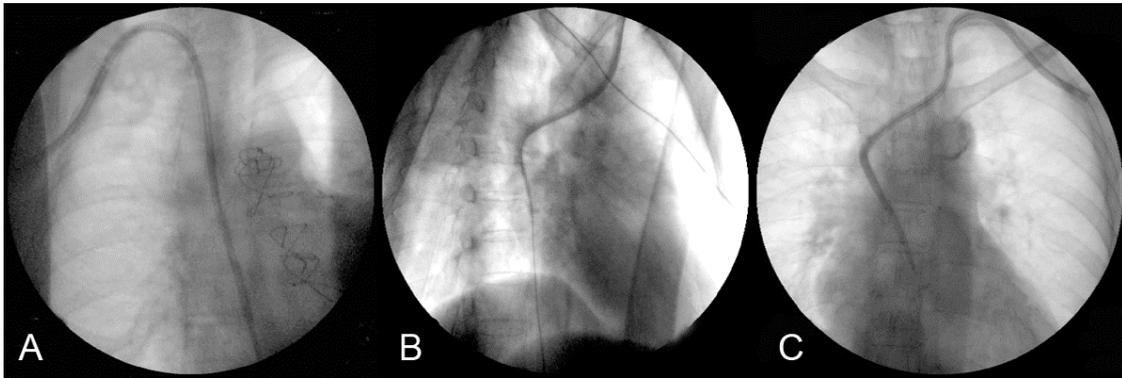
Fig. (2). Catheter in azygos vein. **A** – Catheter from right internal jugular (patient is rotated), **B** – Lateral view, **C** – Catheter from left internal jugular placement (patient is rotated).

The azygos vein enters the thorax through the aortic hiatus in the diaphragm, and passes along the right side of the vertebral column to the fourth thoracic vertebra, where it arches forward over the root of the right lung (arch of the azygos), and ends in the superior vena cava, just before that vessel pierces the pericardium. When a device, guidewire or catheter, has entered the azygos vein, it generally serves as evidence that it is enlarged and is serving as a collateral to carry flow that has been affected by central vein stenosis. The device within this vein will be seen to course diagonally toward the midline (Fig. 2A, C) to lie just lateral to the right side of the vertebral column. This atypical route is even more obvious in a lateral view (Fig. 2B). The device passes

through the azygos arch and courses posteriorly to descend in the posterior portion of the mediastinum [2].

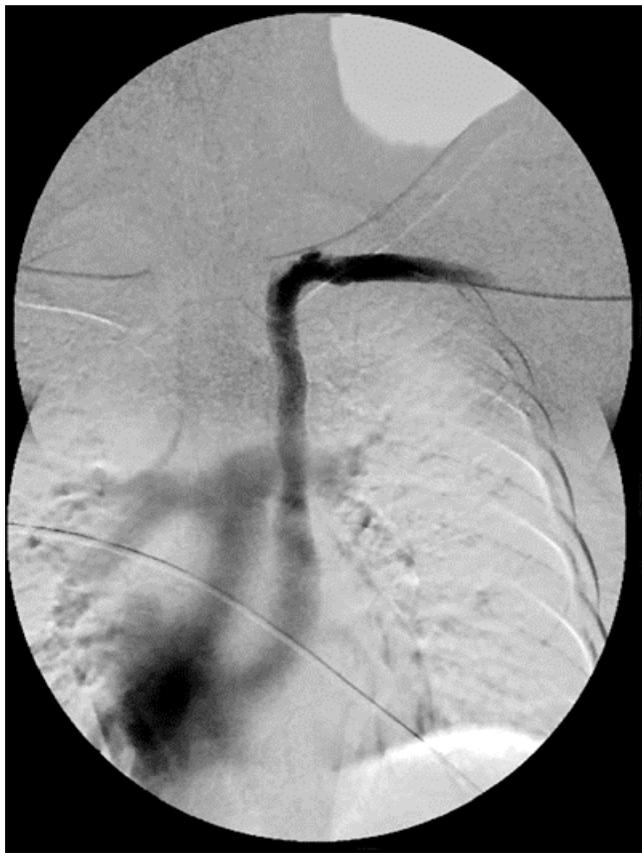
Fig. (3). Left superior vena cava (composite view).

When a guidewire enters a left sided superior vena cava, it is obvious (this is an issue only in left sided catheters). The device passes down the left side of the mediastinum (Fig. 3). Often the first thought is that the brachiocephalic vein has been perforated. This can be excluded by passing a 5 french catheter and injecting radiocontrast. Recognition of this anomaly is very important because the left superior vena cava generally drains into the cardiac sinus and if an attempt is made to pass a guidewire into the atrium, serious cardiac arrhythmias can result.

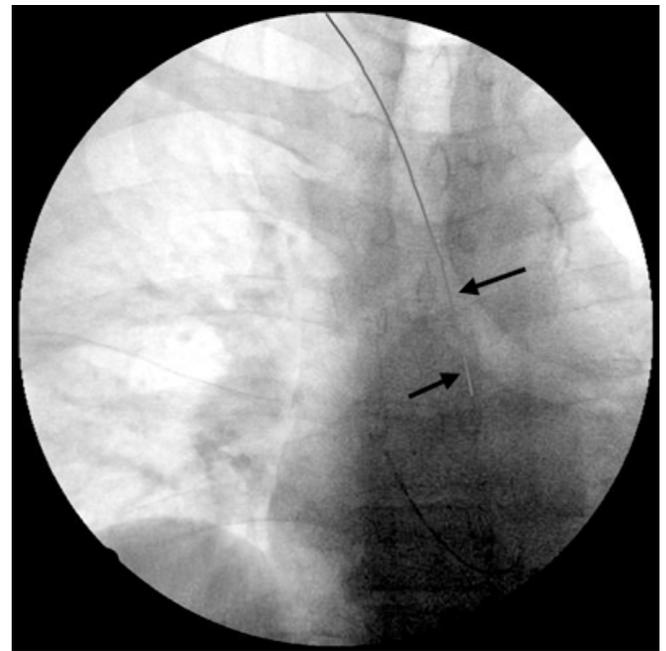
Fig. (4). Guidewire inserted in right carotid artery (arrows) following course of artery and continuing into the thoracic aorta (guidewire has been enhanced for easier visibility).

jugular vein. The pathway from the carotid is then into the thoracic aorta at the arch. The aortic arch passes over the right and behind the left pulmonary artery and then descends. As it descends, it is situated to the left of the vertebral column; it approaches the median line as it descends. A guidewire that is inserted into the carotid and advanced will follow this path as it enters the thoracic aorta (Fig. 4). The device crosses the mediastinum diagonally (from the right) and passes down the left side of the mediastinum to the left of the vertebral column. It is very important that this typical pattern be recognized before inserting something larger than the guidewire into the carotid otherwise a manageable error might develop into an unmanageable problem requiring surgical intervention.
